Gold Star Inspections
2129 Trebein Rd
Xenia, Ohio 45385

100 Smith Way
Imaginary City, Ohio 99999

15:22 March 14, 2019

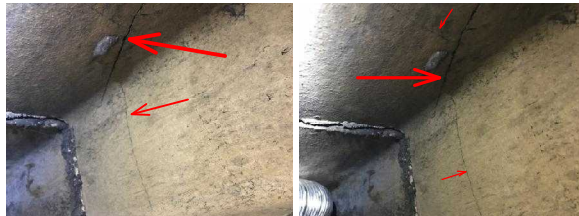
14. Flue/Flue Cap: Clay, Metal - Chimney liner is cracked at basement clean out. Chimney has a metal liner.

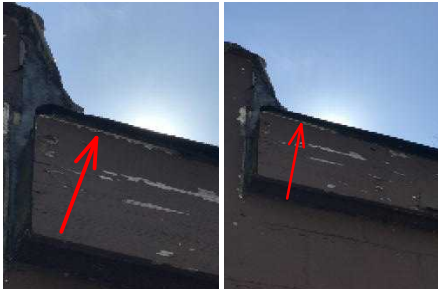
7. Facia: Unknown - **Drip edge is missing or out of place. Light can be seen inside the garage. Wood rot.**

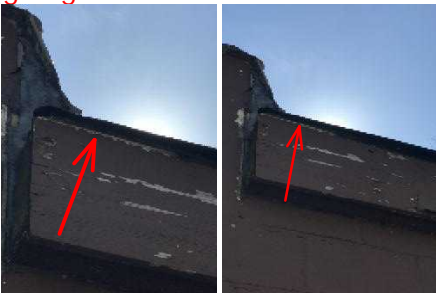
-
6. Detached rear Garage Facia: Unknown - **Drip edge is missing or out of place. Light can be seen inside the garage. Wood rot.**
